DRAGONFLY BUILDERS AND FLYERS NEWSLETTER

13th Annual Tandem Wing Field of Dreams Fly-In

Volume 105

September/October 2003

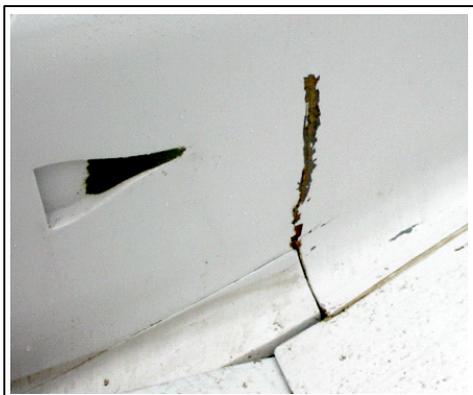
Looking at the outside of the fuselage in the area where the canard drag bulkhead attaches, I noticed (on both sides) that the glass was broken. This exhibited itself as two vertical lines of unpainted area approximately 1/2" wide, exposing torn fabric, extending up about 12". (See photo below) The surface was rough glass, obviously fractured from the "arrival". This

fracture appeared on the outside as well as the inside of the fuselage. This area is one of the strongest areas of the fuselage and it had gone through a failure mode similar to attempting to open as if it were the front of a C5A, or that pregnant Airbus that appeared a OSH this year. On the top of the front turtle deck, there was a rip extending from the front right corner of the access panel forward to the right approaching the firewall.

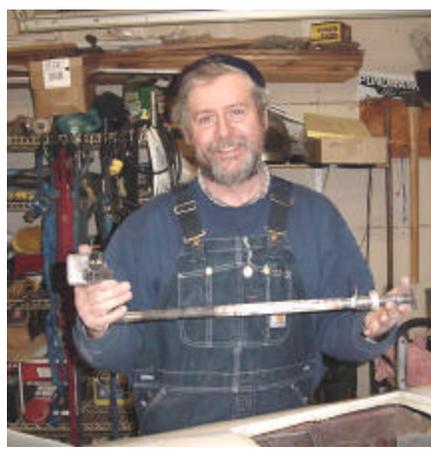
Joe has built his own 1836 VW engine to power his Dragonfly. The

engine has one magneto and one electronic ignition that he built from Chrysler and Chevy automotive ignition parts. But even though Joe has a very nice running installed engine.....for a variety of reasons, Joe decided to change his engine. Joe will be installing a Continental ground power unit (GPU) engine which is very similar to a C-90 or O-200. With very few modifications, Joe will get a rock solid 100 HP.
